Annual Inspection

Barton Stacey Parish Council

Back Field

The Green , Barton Stacey , Hants , SO21 3RY

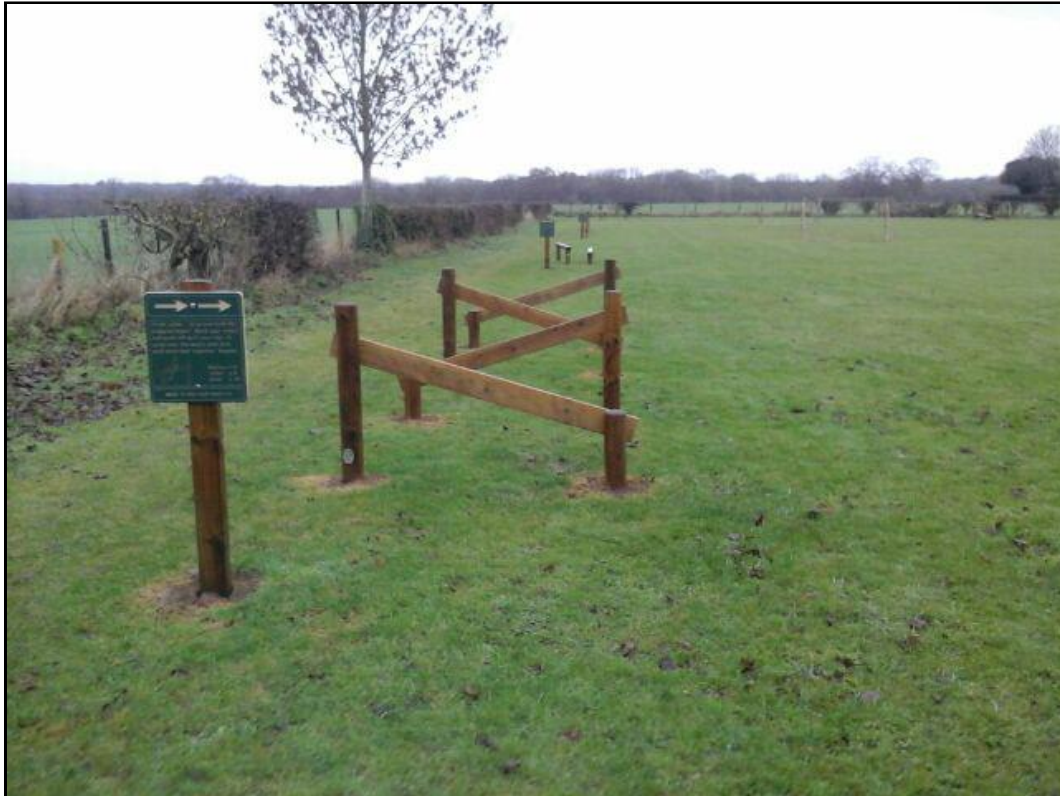
Risk Assessment: V 4 Very Low Risk

The site is located in an area of public open space and is not directly overlooked by any properties in the local community.

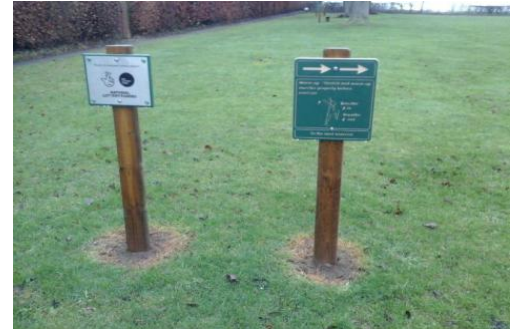
Item: Sign
Manufacturer: Not Identified
Surface Type: N/A
Equipment Compliance: N/A
Surface Area Compliance: N/A

4 - Very Low Risk

Signage should be provided at the facility in accordance with the requirements of BS EN 16630, key requirements of the sign include, but are not limited to, intended users, medical safety and emergency contact details - Provide appropriate signage

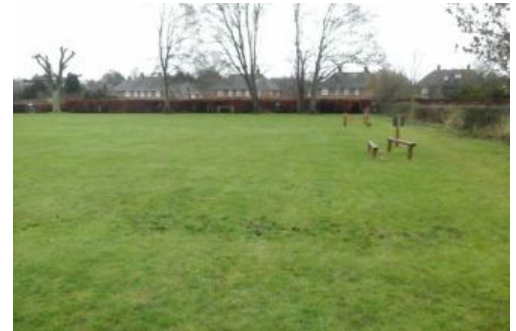
Item: Site General
Manufacturer: Owner/Operator
Surface Type: N/A
Equipment Compliance: N/A
Surface Area Compliance: N/A

Total Findings: 0

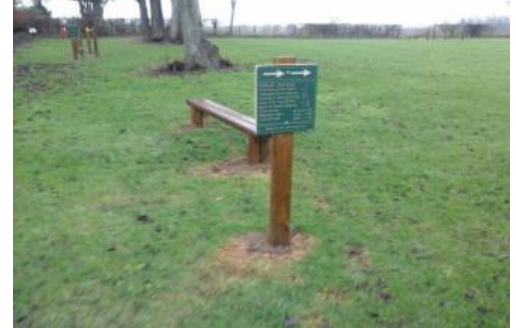
Item: Agility Bench
Manufacturer: Fawns Recreational Services Ltd
Surface Type: Grass
Equipment Compliance: Yes
Surface Area Compliance: Yes
Life Expectancy: 5 -10 Years

This item is satisfactory - no work required -

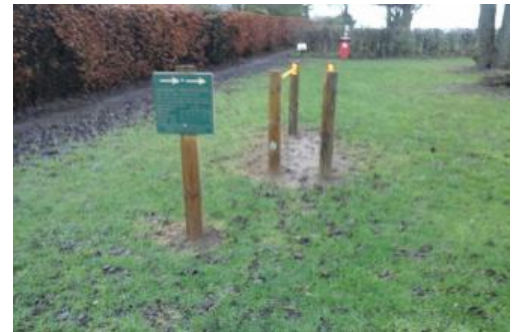
Item: Parallel Bars
Manufacturer: Fawns Recreational Services Ltd
Surface Type: Grass
Equipment Compliance: Yes
Surface Area Compliance: Yes
Life Expectancy: 5 -10 Years

This item is satisfactory - no work required -

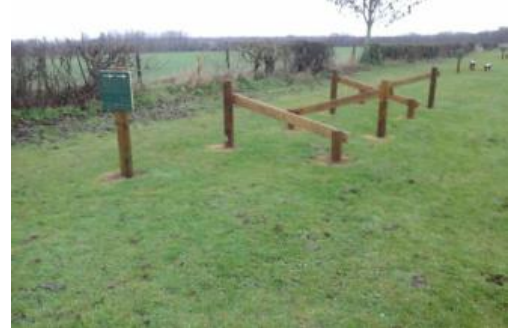
Item: Hurdles
Manufacturer: Fawns Recreational Services Ltd
Surface Type: Grass
Equipment Compliance: Yes
Surface Area Compliance: Yes
Life Expectancy: 5 -10 Years

This item is satisfactory - no work required -

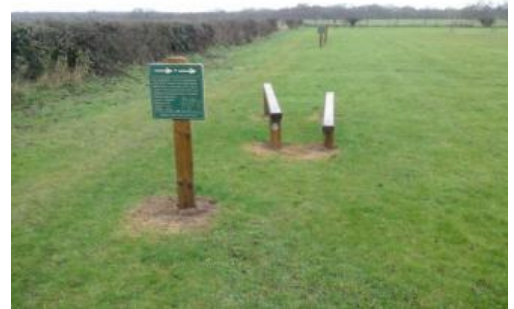
Item: Sit Up Station
Manufacturer: Fawns Recreational Services Ltd
Surface Type: Grass
Equipment Compliance: Yes
Surface Area Compliance: Yes
Life Expectancy: 5 -10 Years

This item is satisfactory - no work required -

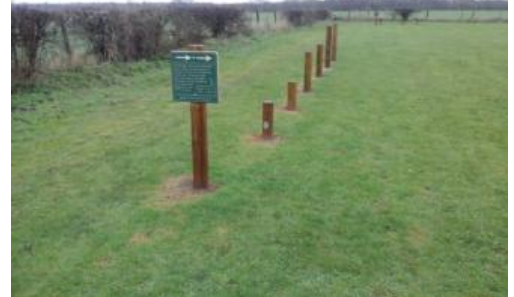
Item: Agility Posts
Manufacturer: Fawns Recreational Services Ltd
Surface Type: Grass
Equipment Compliance: Yes
Surface Area Compliance: Yes
Life Expectancy: 5 -10 Years

This item is satisfactory - no work required -

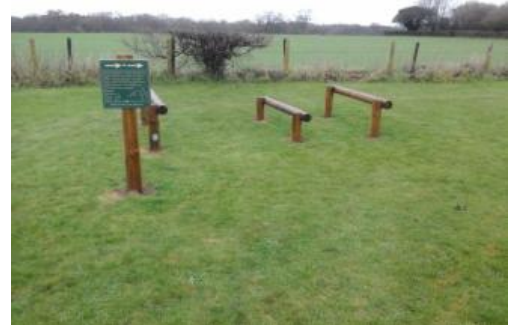
Item: Press Up Station
Manufacturer: Fawns Recreational Services Ltd
Surface Type: Grass
Equipment Compliance: Yes
Surface Area Compliance: Yes
Life Expectancy: 5 -10 Years

This item is satisfactory - no work required -

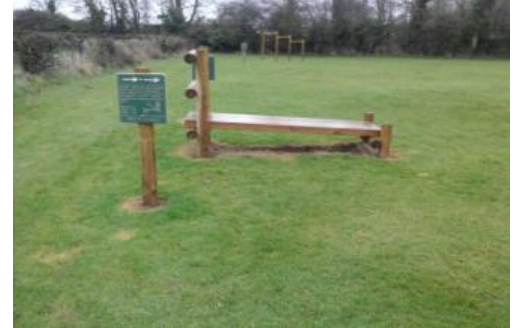
Item: Sit Up Station
Manufacturer: Fawns Recreational Services Ltd
Surface Type: Grass
Equipment Compliance: No
Surface Area Compliance: Yes
Life Expectancy: 5 -10 Years

This item is satisfactory - no work required -

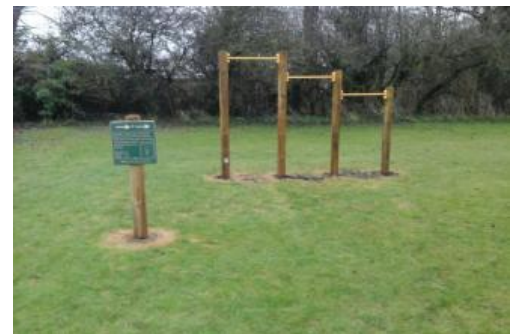
Item: Pull Up Station
Manufacturer: Fawns Recreational Services Ltd
Surface Type: Grass Matrix Tiles
Equipment Compliance: Yes
Surface Area Compliance: Yes
Life Expectancy: 5 -10 Years

This item is satisfactory - no work required -

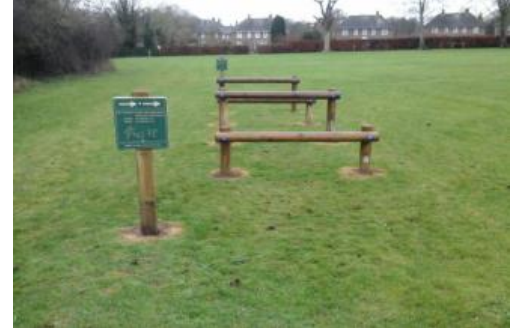
Item: Beam Jump
Manufacturer: Fawns Recreational Services Ltd
Surface Type: Grass
Equipment Compliance: Yes
Surface Area Compliance: Yes
Life Expectancy: 5 -10 Years

This item is satisfactory - no work required -

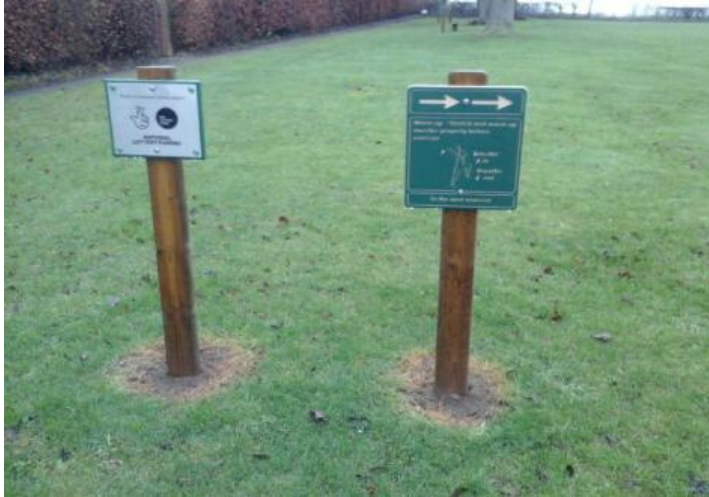
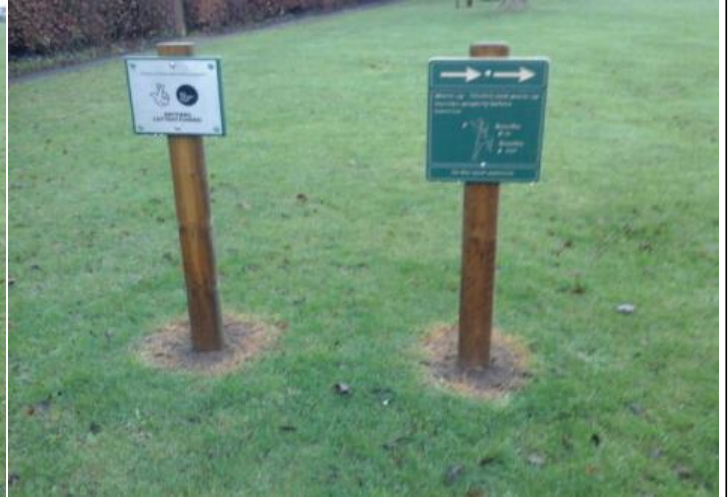
Item: Ancillary Items - Sign
Manufacturer: Not Identified

Risk Level: V - Very Low Risk
Surface: N/A

Finding: Signage should be provided at the facility in accordance with the requirements of BS EN 16630, key requirements of the sign include, but are not limited to, intended users, medical safety and emergency contact details

Action: Provide appropriate signage
